Macallen Dam Feasibility and Impact Analysis

Dam Committee Update Meeting Draft Feasibility Study Results Lamprey River, Newmarket, NH

Gomez and Sullivan Engineers

May 19, 2014

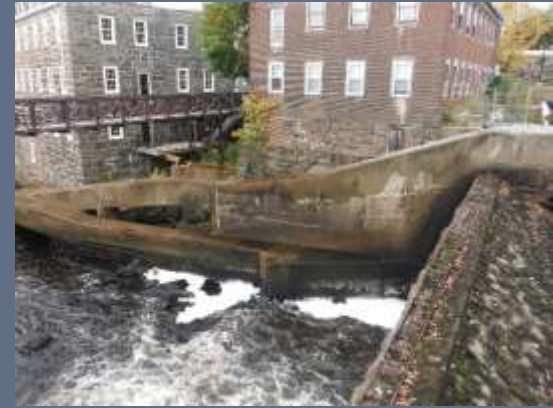
Environmental Information - Fish Passage

- Dam equipped with denil-style fish ladder; owned/operated by NHFGD
- Since 1972 , NHFGD estimates ~1.4 million river herring have passed through the ladder
- Other native species use the fishway including Atlantic salmon, sea lamprey and American eel
- Ladder is 3-feet wide, which is appropriate for river herring, but some species like American Shad may prefer a wider structure
- Young-of-the-year American elvers (eel) cannot effectively navigate the ladder due to high velocities
- Seasonal operation of the ladder prevents resident species from having year-round access to upstream waters
- Lowering the dam spillway crest would impact the fishway

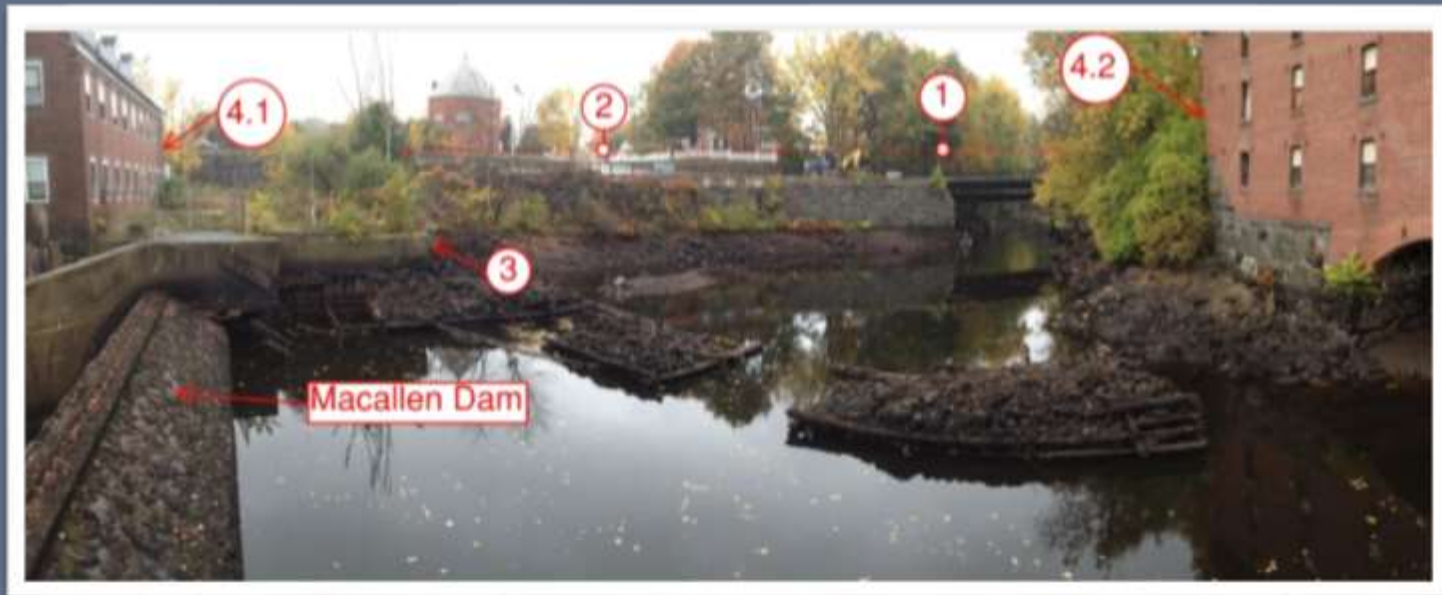
Infrastructure Information – HTA

- HTA inspected the Veterans bridge, retaining walls and the building foundations adjacent to the dam (Durham Book Exchange and former Selectwood buildings)
- Limited to a visual inspection only during Oct 2013 drawdown – no structural calculations or testing was completed
- Veterans Bridge and retaining wall appears to have a low scour risk and no further investigation is recommended

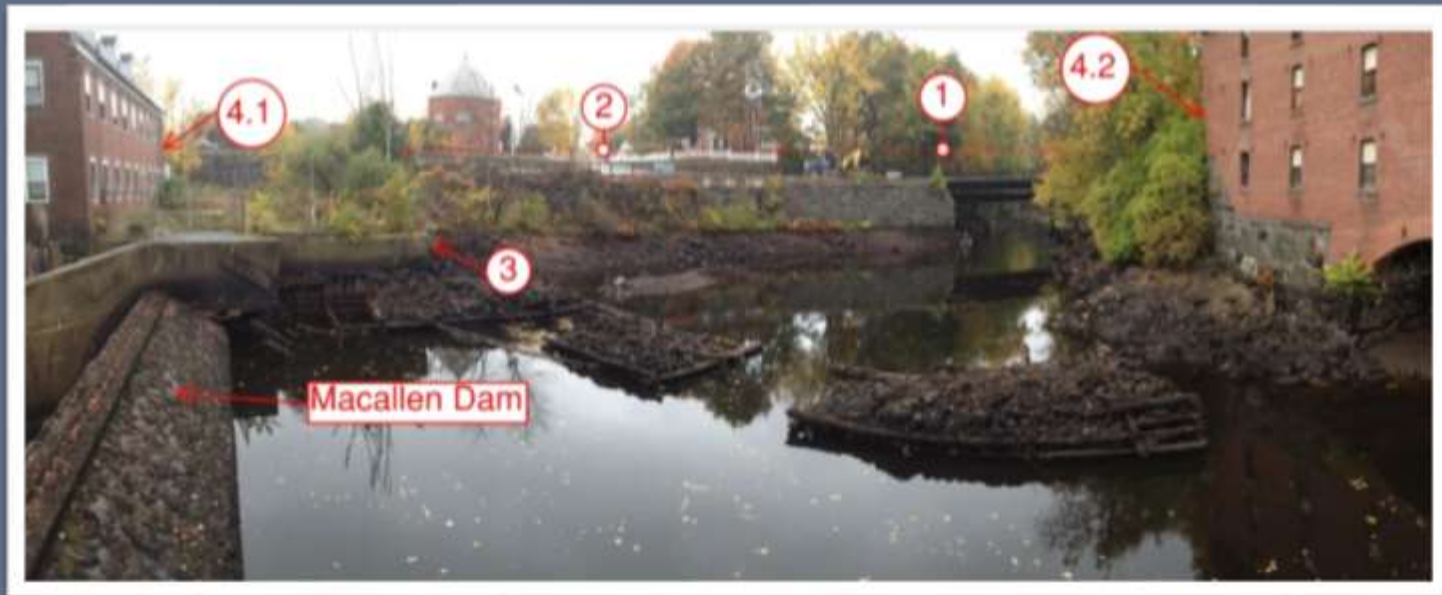
Infrastructure Information – HTA

- No further investigation necessary at Durham Book Exchange building as long as the Town places sandbags under high flows
- Further scour evaluation at the Selectwood building is recommended, as the foundation has areas of concern
- The two railroad bridges were not investigated; any further work should evaluate potential impacts to those crossings

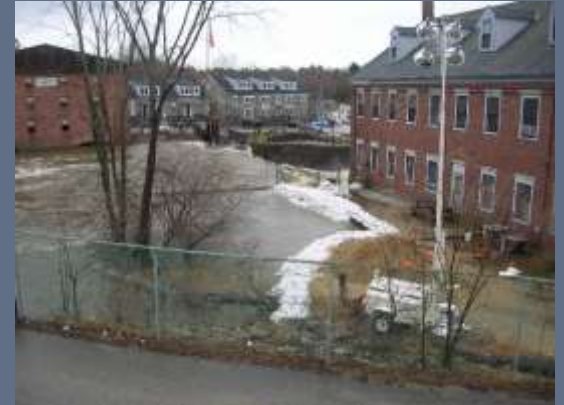
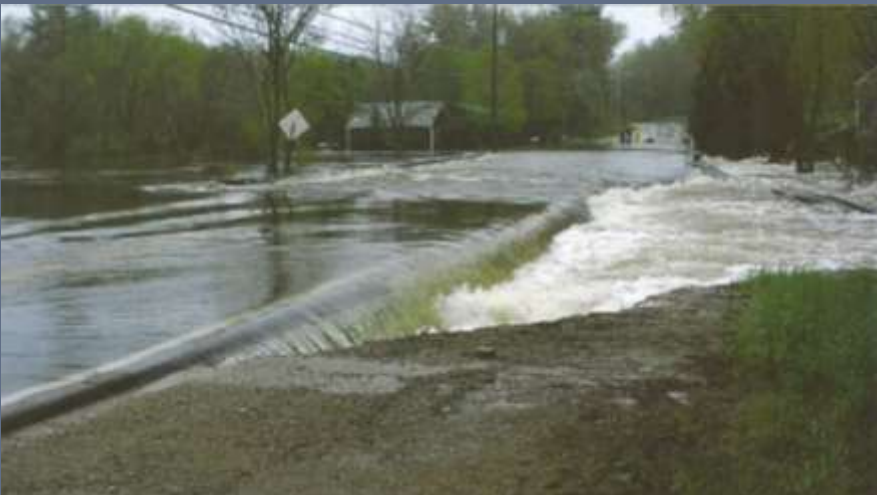
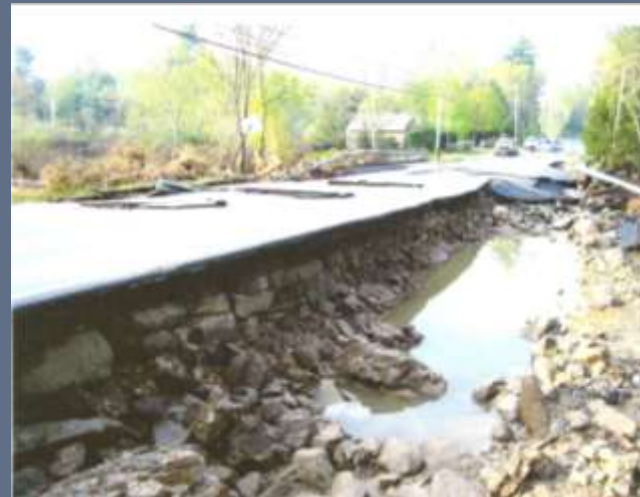
Hydrologic Analysis – Flood Flows

- Wright-Pierce 100-year flood flow has 15,875 cfs entering the Macallen Dam impoundment and ‘flow split’ area:
 - Mainstem Lamprey River: 12,670 cfs
 - Piscassic River: 1,850 cfs
 - Tributaries: 1,350 cfs
- 10,260 cfs passes to Macallen Dam
- 5,615 cfs passes to the Oyster River watershed

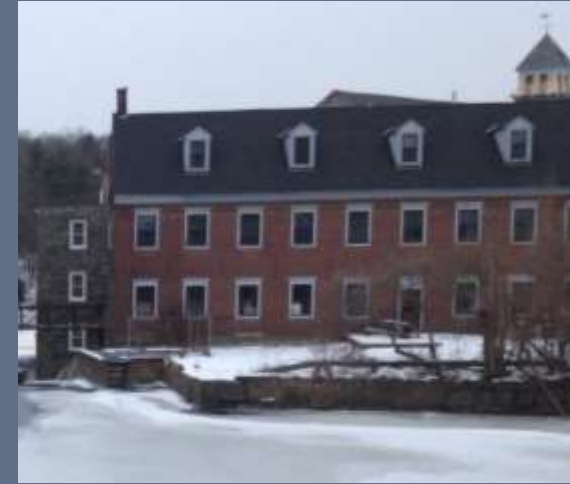
- Buy and remove Durham Book Exchange Building and raise the right abutment. Per NHDES Sep 2010 letter the main concern with dam failure is the habitation of this building.
- Various combinations of widening the spillway, partially or fully removing the gates and adding flashboards.
 - Limited ability to widen spillway due to infrastructure
 - NHDES typically requires a low-level outlet
 - Loss of flashboards would render fish passage ladder inoperable
 - Loss of flashboards would result in more water flowing toward dam
- Construct new dam between Veteran's Bridge and Macallen Dam as the channel width is much wider
